# WELDING INSPECTION REPORT

Resident Engineer: Casey, William **Report No:** WIR-030030

**Project Name:** SAS Superstructure **OSM Arrival Time:** 700 **OSM Departure Time:** 1530 **Prime Contractor:** American Bridge/Fluor Enterprises, a JV Contractor: American Bridge/Fluor Enterprises, a JV **Location:** Job Site

34-0006 **Bridge No: Component: SAS** Tower

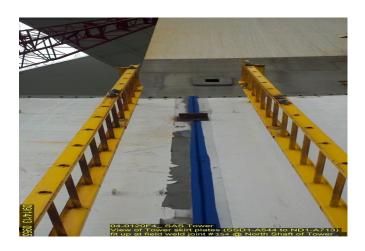
Weld# 154 @ North Shaft

The QA Inspector observed that ABF welder Kit Lai (WID-2953) was performing fit up and tack welding on Tower Skirt plate vertical weld joint #154 on Skirt plates ND1-A713 to SSD1-A544. ABF will be welding the first 500mm of the vertical weld to aid in installation of upper skirt plate sections. The QA Inspector and QC Inspector Tony Sherwood observed the gap of the weld joint at 7mm with steel backing. Per ABF Request For Information (RFI) 003417R02 the contractor is approved to use steel backing bar that will remain in place,up to a maximum of 8mm root gap. The original weld detail per the approved drawings (FWT-21) is a single vee Partial Joint Penetration (PJP) weld with 60° groove, 13mm landing and 0-gap (C-P2-GF). Mr. Sherwood stated that welding parameters and preheat are based off of Welding Procedure Specification (WPS) ABF-WPS-D15-2140-3. Mr. Lai was then observed preheating the weld to over 250° Fahrenheit using a propylene torch. The welding was being performed with the Flux Cored Arc Welding (FCAW) process using 1.8mm diameter electrode Innershield NR-232. The welding parameters were verified by Mr. Sherwood with a Fluke 337 current Clampmeter and preheat was verified with temperature indicators. The QA Inspector observed welding parameters at 230 amps with 22 volts. The QC Inspector performed welding parameters verifications at random intervals throughout the shift. The QC Inspector stated that ABF QC would perform Magnetic Particle Testing (MT) of all root passes and 10% MT of the final cover passes. The work is expected to continue with initial welding of the Skirt plate splice welds on 9-16-13.
